# Bedrock Control of a Boulder-Filled Valley Under the World Trade Center Site

**Cheryl J. Moss**, Mueser Rutledge Consulting Engineers, 14 Penn Plaza, New York, NY 10122 (cmoss@mrce.com), and,

**Charles Merguerian**, Geology Department, 114 Hofstra University, Hempstead, NY 11549 (geocmm@hofstra.edu; charlesm@dukelabs.com)

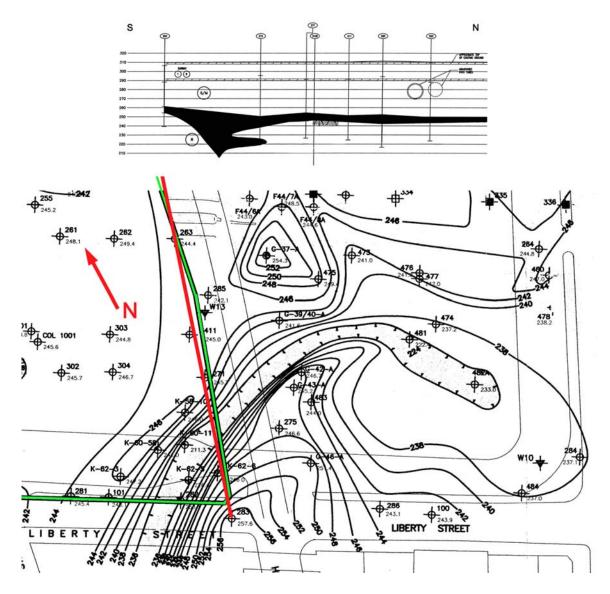
**Figure 1** – SE corner of the World Trade Center site. Top - Cross-section along Greenwich Street at the corner of Liberty Street facing west, showing a ledge in the bedrock above a valley filled with boulders. Bottom - A contour map based on old borings shows where the boulder filled valley cuts across the SE corner of the West Bathtub slurry wall (green line). The red line shows the location of the cross-section. Elevation 300' is equal to El +2.653' on USGS Mean Sea Level Datum at Sandy Hook, NJ (1929 NGVD).

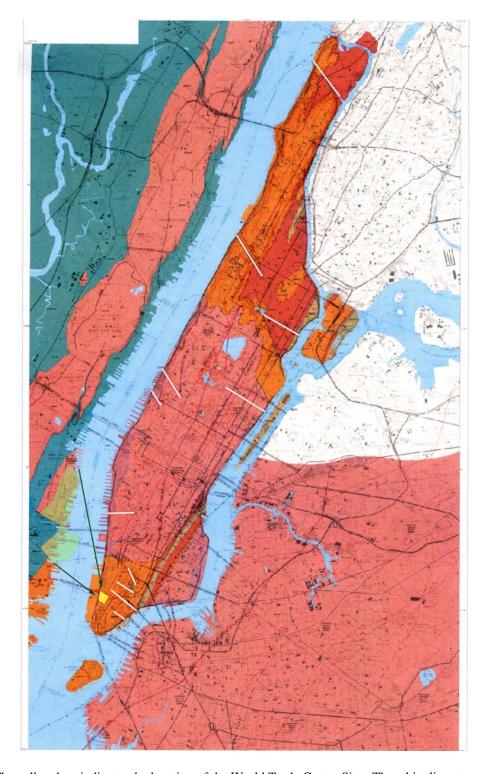
**Figure 2** – The yellow box indicates the location of the World Trade Center Site. The white lines trace the locations of valleys that cut through the bedrock across Manhattan. These valleys are typically filled with glacial sediment, predominantly outwash sand and varved silt and clay. When present, glacial till is typically found directly above the bedrock. Areas colored in light green mark bodies of New Jersey serpentinite that are the source of the serpentinite gravel found in the WTC till, indicating glacial flow from the NW. (Basemap from Baskerville, 1994.)

The boulder filled glacial valley with a NE alignment is an unusual feature for Manhattan. On a 20 foot contour map scale, Baskerville (1994) noted several NW-SE trending valleys that cut through the bedrock across New York City (Figure 2). They are typically filled with glacial sediments, predominantly outwash sand and varved silt and clay. Glacial till is often, though not always, present, usually directly above the bedrock of NYC. Boulders and cobbles can be scattered throughout, though they are typically found in the till. Where the shape of the bedrock surface creates an obstruction to flow, boulders are especially prevalent on the NW side, indicative of NW to SE paleoflow directions. The valleys are well defined in northern Manhattan and there are several present in the subsurface in southern Manhattan. A combination of two different geological processes, faulting and subsequent glacial erosion, are likely responsible for their presence.

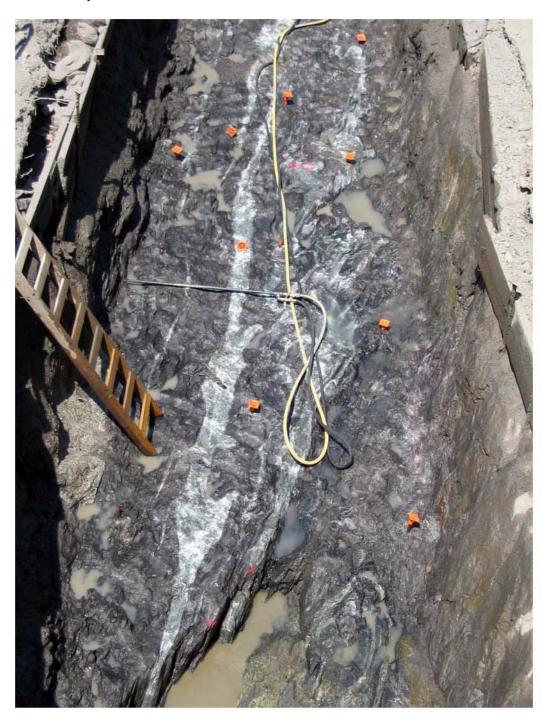
**Figure 3** – Vertical asymmetric fold of Walloomsac calc-silicate and interlayered schist found in an excavation along the eastern edge of the west bathtub. (Digital image by C. J. Moss.)

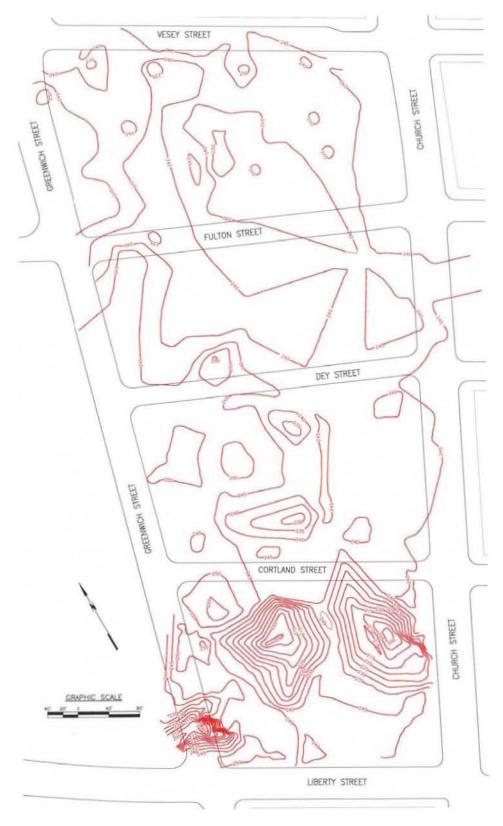
**Figure 4** – Bedrock contours in the East Bathtub based on the newest borings and construction data. The valley consists of two bowl-like depressions that trend WNW before heading SW into a narrow valley that runs offsite, below Liberty Street. Elevation 300' = El +2.653' (1929 NGVD).

Before any new construction could take place at the WTC site east of the existing bathtub, a new eastern slurry wall had to be built. A contour map was made of the top of bedrock in the east bathtub using all available subsurface information (Figure 4). The top of rock surface was gently undulating except in the southern quarter of the site. There the new information revealed that the valley consisted of two large bowl-like depressions in the center of the bathtub. Heading eastward into Church Street, construction of the new slurry wall indicated the depressions narrowed into a deep channel filled with boulders. Anecdotal evidence from drilling operations suggested that a bedrock ledge, similar to the one found in the west bathtub

was also present at this point. The bedrock depressions led west-northwestward into a deep narrow channel, the same one that cut the west bathtub. From the west bathtub the valley curves southwest off site below Liberty Street. The precise nature of this portion of the valley will not be known until the Deutsche Bank building is demolished and new construction can start on the south side of Liberty Street.

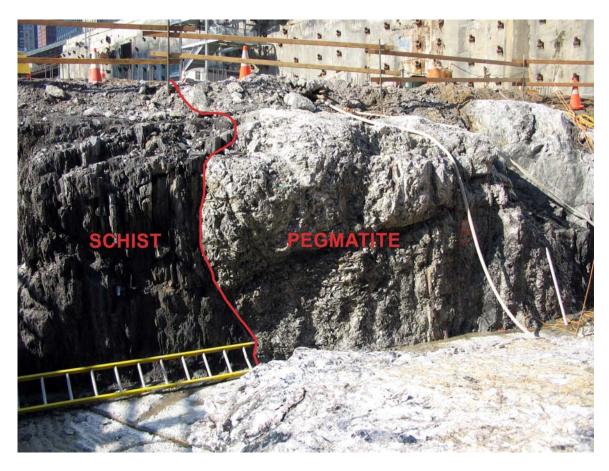
**Figure 5** – Pegmatite intrusive (seen on the right) into schistose rock in the NW corner of the WTC site. The pegmatite is essentially the same in both the NW and SE corners of the site. (Image by C. J. Moss.)

Based on borings and our field investigations, the bedrock in the east bathtub is predominantly schist and gneiss with pegmatite veins cutting across the site. In the southern third of the site, however, large masses of pegmatite appear. These bodies are essentially identical to the ones that are present in the northwest corner of the west bathtub (Figure 5). At the WTC site schistose rock in contact with pegmatite tends to become more recrystallized and gneissic in character. This rock is significantly harder than the schist across much of the location, so it is typically more resistant to erosion. In each of the borings that contained the bouldery till, it was found directly above a layer of bedrock that was more gneissic than what was typical for the site.

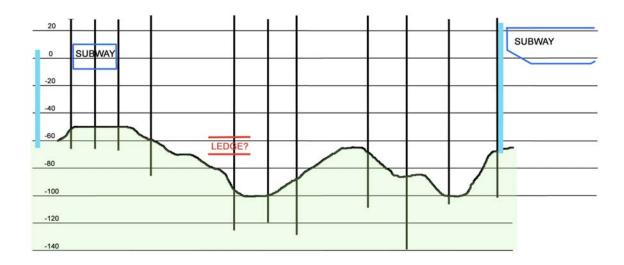
**Figure 6** – Cross-section through the depressions in the east bathtub, facing north. Red lines show the location of either a ledge of bedrock or an 11 foot thick pegmatite boulder. Location of cross-section is shown in Figure 7. Elevation 0' is equal to El +2.653' on USGS Mean Sea Level Datum at Sandy Hook, NJ (1929 NGVD).

The sediment load carried by the glacial ice and meltwater scoured away the softer rock, eroding it down to the zones of harder gneiss. The resulting depressions were then filled with the boulders and cobbles too large to be carried away by the swift currents and possibly trapped by the steepening walls around them. Ledges of hard bedrock may have been left behind as underlying weaker zones were cut out and glacial streams changed location (Figure 6).

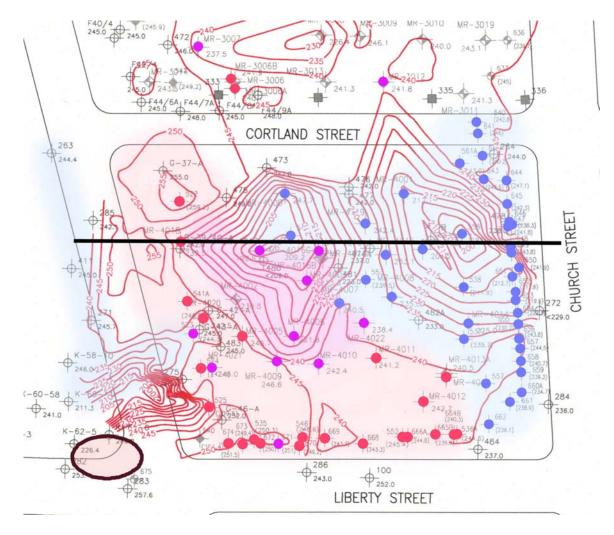
**Figure 7** – Borings in pink are pegmatite, blue indicates schist and gneiss, purple indicates that a mixture of pegmatite and schist/gneiss is found in the boring. Construction of the west bathtub revealed a mass of pegmatite (circled) at the SE corner, on the SE side of the glacial valley. The valley and the rest of the slurry wall was in schistose rock. The black line shows the location of the cross-section in Figure 6. Elevation 300' is equal to El +2.653' on USGS Mean Sea Level Datum at Sandy Hook, NJ (1929 NGVD).

The contact zone between the pegmatite intrusives and the surrounding schistose rock is what controls the presence and nature of the glacial valley in the southeast corner of the WTC site. Along the western and southern sides of the east bathtub the bedrock is comparatively high and level compared to the rest of the site (Figure 7). This "plateau" is underlain by pegmatite. Towards the north and east, at the edges of the depressions, the rock becomes a mix of pegmatite and more schistose rock. Farther to the northeast, below the depressions, the rock is predominantly schistose. A mass of pegmatite was also found just east of where the valley crossed the slurry wall in the west bathtub. The pegmatite intrusives typically altered the surrounding rock infusing it with quartz and recrystallizing it as a more gneissic material. The hard pegmatite and gneiss are more resistant to the effects of glacial scour than the more schistose country rock.
